OSWEGO RIVER BASIN
PUNCH BOWL DAM

SCHUYLER COUNTY, NEW YORK
INVENTORY NO. N.Y. 1343

PHASE I INSPECTION REPORT
NATIONAL DAM SAFETY PROGRAM
PUNCH BOWL DAM
N.Y. 1343
DEC I.D. NO. 60C-4405
OSWEGO RIVER BASIN
SCHUYLER COUNTY, NEW YORK

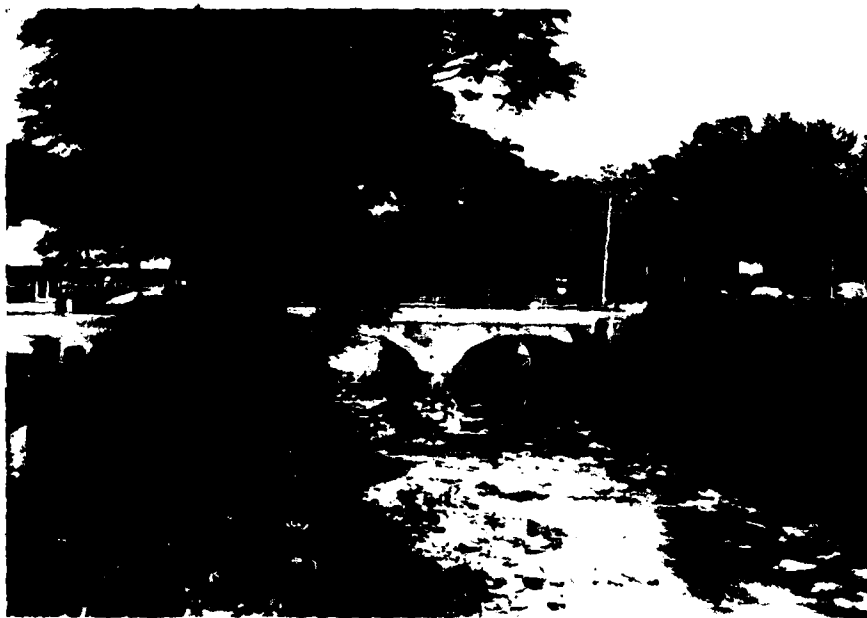
PHOTOGRAPH NO. 6
City of Watkins Glen
(1.5 miles downstream)
